Patient safety

Paving the way for progress

← → **N°7**
March 2015

RECORD AND VERIFY : RECORDING ERRORS

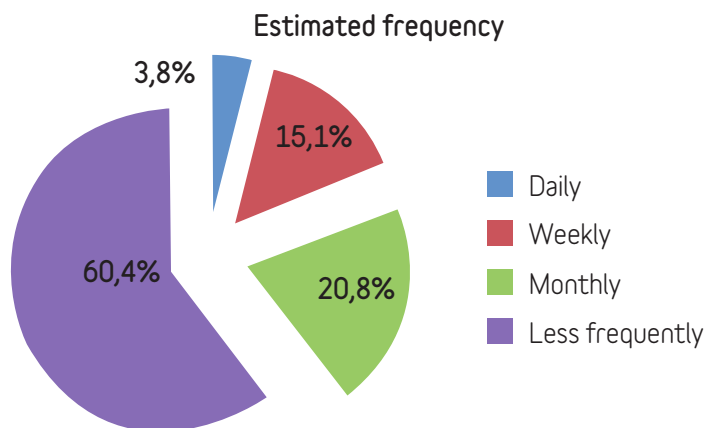
40% of the respondent centres encounter the problem at least once a month.
