Patient safety

Paving the way for progress

← → N°8
June 2015

Pulsed Dose-Rate and High Dose-Rate Brachytherapy

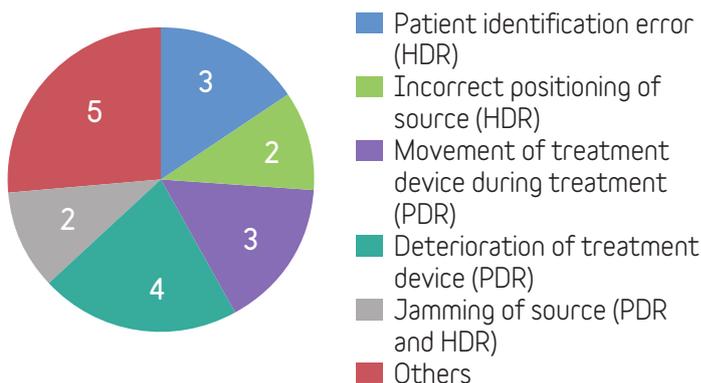
Distribution by cause of the 19 notified ESRs in brachytherapy
